# Case Study: Fume Elimination Fan Split Pillow Block - GUARDIAN™

A primary metals manufacturer of electrical and stainless steel products.

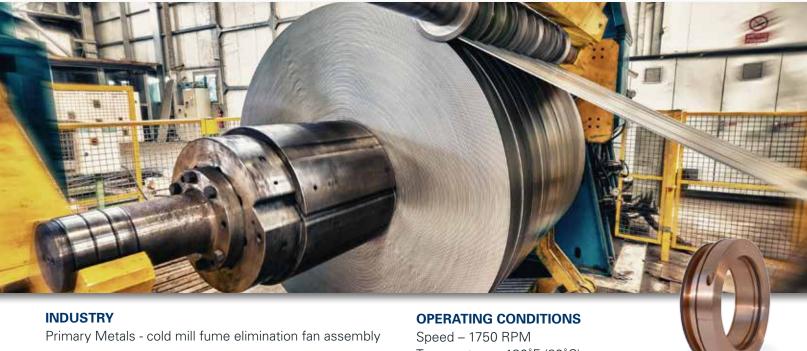
The superior Garlock split GUARDIAN™ (29716-6292) split pillow block bearing isolator design allowed the mill to operate without premature bearing failure in the fume elimination fan application to optimize performance.
