Case Study: Cement Plant

MICRO-TEC® II

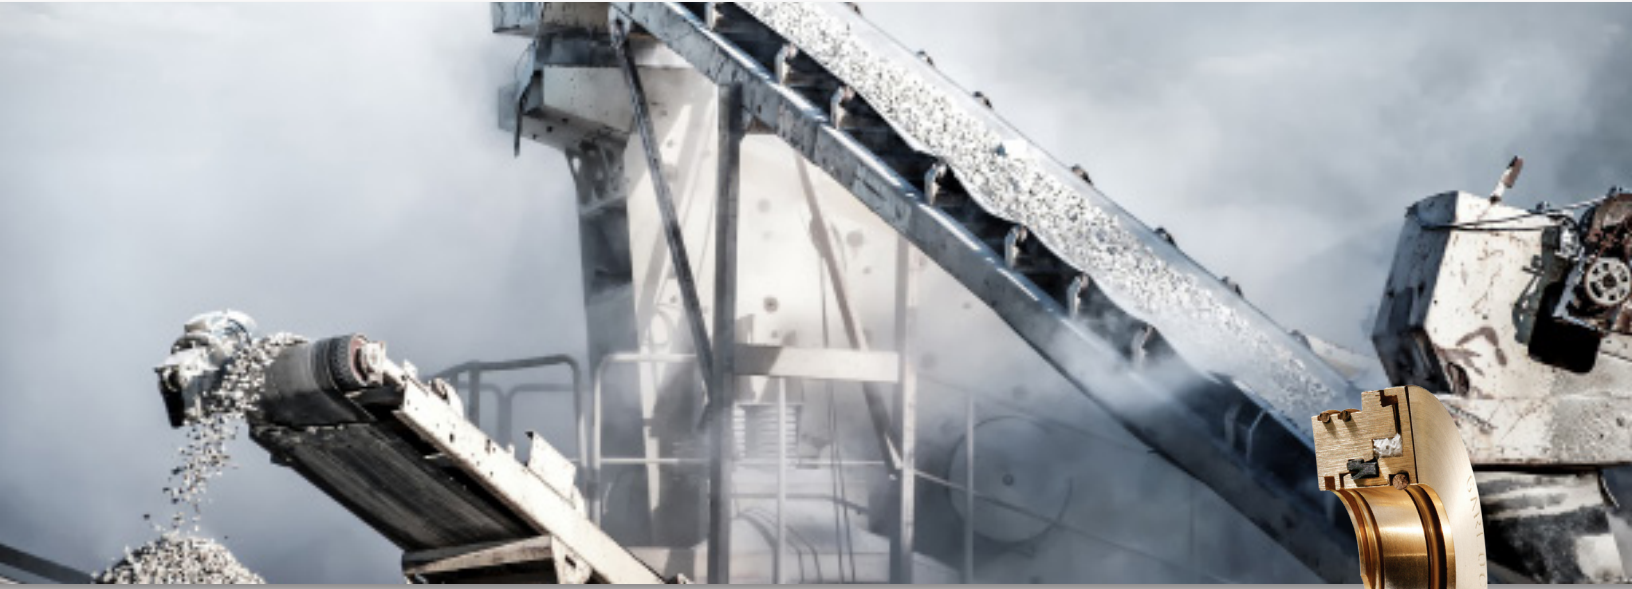
Garlock recommended a custom split MICRO-TEC® II bearing isolator. The MICRO-TEC® II offered superior lubrication retention, while its microcellular foam filter excluded external contamination. Its non-contact design eliminated the challenges produced through continual use of contact seals without the need for a costly overhaul. Since it was offered in a split configuration installation was quick and simple, getting them back up and running in minimal time. Savings from lost production, continual seal & bearing replacement and periodic fines amounted to over \$800,000.
