Troubleshooting your piping integrity takes a joint effort

A robust maintenance plan will expand life expectancy of nonmetallic expansion joints

By Sherwin Damdar and Stephen Cramb
Garlock Sealing Technologies

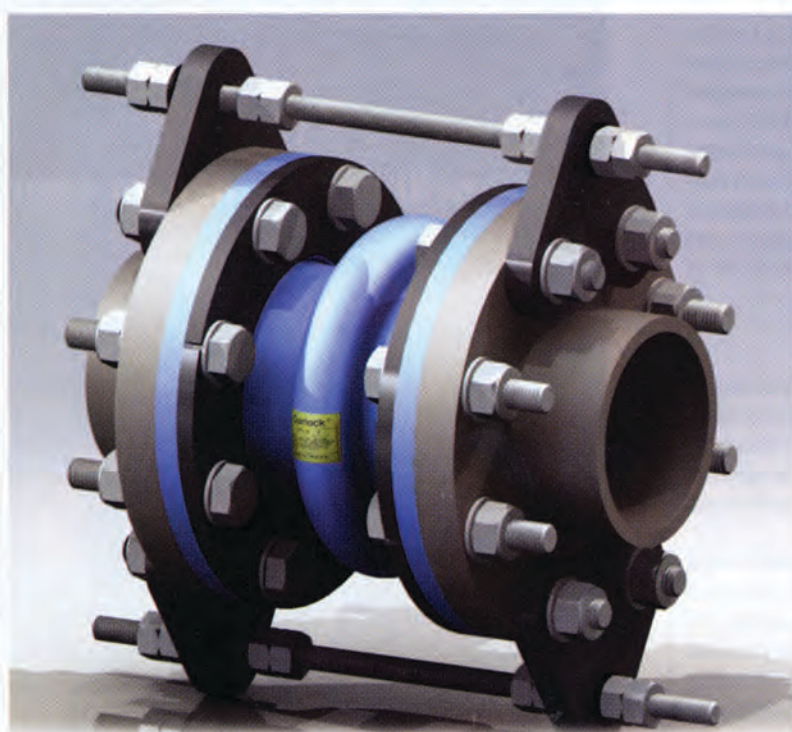
Figure 1: This spool-type expansion joint with control units features a single arch to accommodate both angular and linear pipe movement. Courtesy: Garlock Sealing Technologies

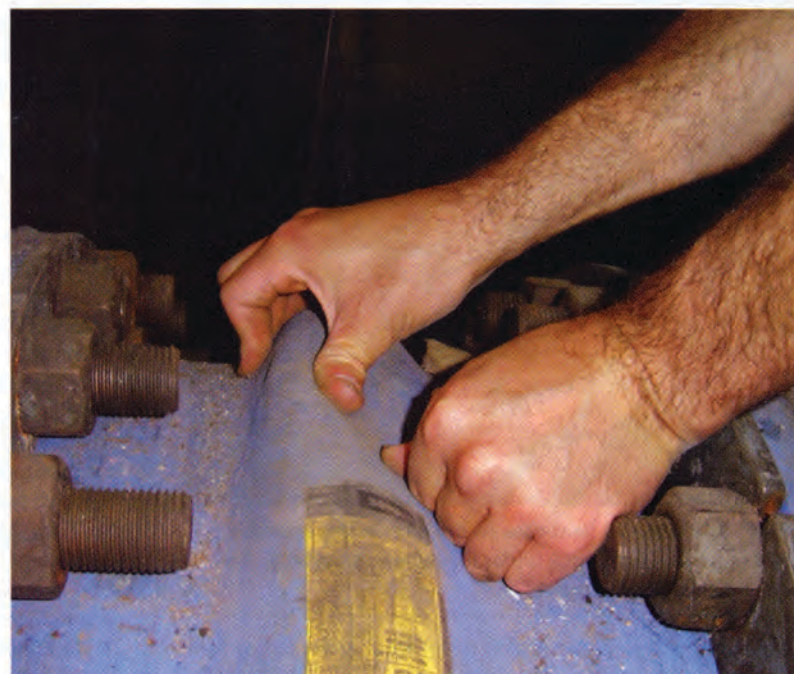
Figure 2: A soft arch that can be pressed into indicates the tube inside the expansion joint has been compromised, allowing aggressive media to come into contact with the body and cover. Courtesy: Garlock Sealing Technologies

Elastomer expansion joints tend to fail from the inside, where flow conditions can adversely affect the entire assembly. Of the three basic components of an expansion joint, the tube is the most critical, serving as both the physical and chemical boundary between the body and the media. If the tube is compromised, the body that provides the joint's strength can be exposed to the media, potentially causing it to degrade. Therefore, it is critical to note the condition of the tube when

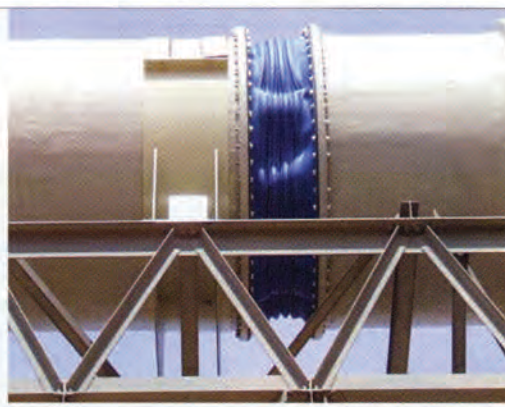
Figure 3: Excessive system vacuum caused the arch in this large expansion joint to collapse. Courtesy: Garlock Sealing Technologies

Expansion joint failures are caused by a variety of factors. As noted, failures of nonmetallic expansion joints, especially elastomeric types, are usually preceded by perceptible warning signs. For example, the arch inversion shown in Figure 3 indicates system vacuum exceeded the joint's specified expansion value. Another warning sign is cracking at the base of the arch, which indicates the joint has been over-elongated and should be replaced with one of the proper length. If the arch is soft and easily deformed, the tube has been chemically attacked or cracked from the inside. In this case the compatibility of the tube and media needs to be reexamined.

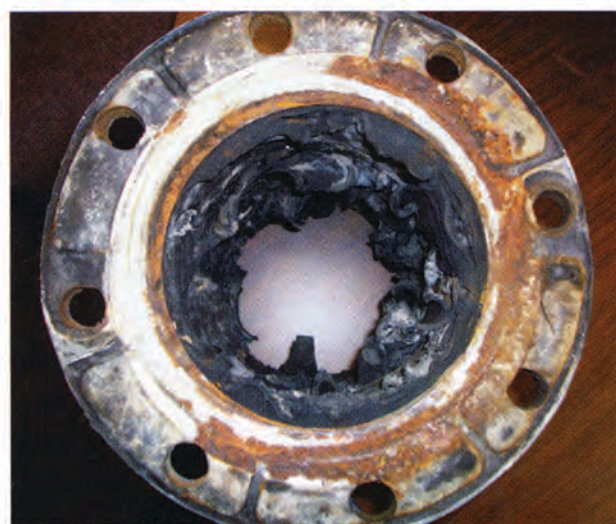
Figure 3: Excessive heat caused the tube in this expansion joint to harden and crack under movement. Courtesy: Garlock Sealing Technologies

can cause it to leak or burst. In other instances the tube may have hardened from excessive temperatures, causing it to lose its resilience and crack under dynamic movement.
