Case Study: GYLON EPIX® 3500 Pulp and Paper Manufacturer

Pulp and Paper

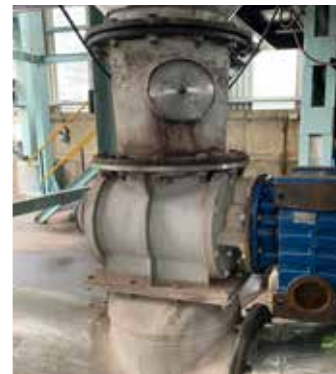
The mechanical foreman on site confirmed that the first GYLON EPIX® 3500 gasket was installed in June of 2019 and is still in operation as of January of 2020, far exceeding the life of former gaskets. Due to the success, plant maintenance is planning to install GYLON EPIX® in more rotary valve flange connections and steam applications.
